Hardware Findings & Recommendations

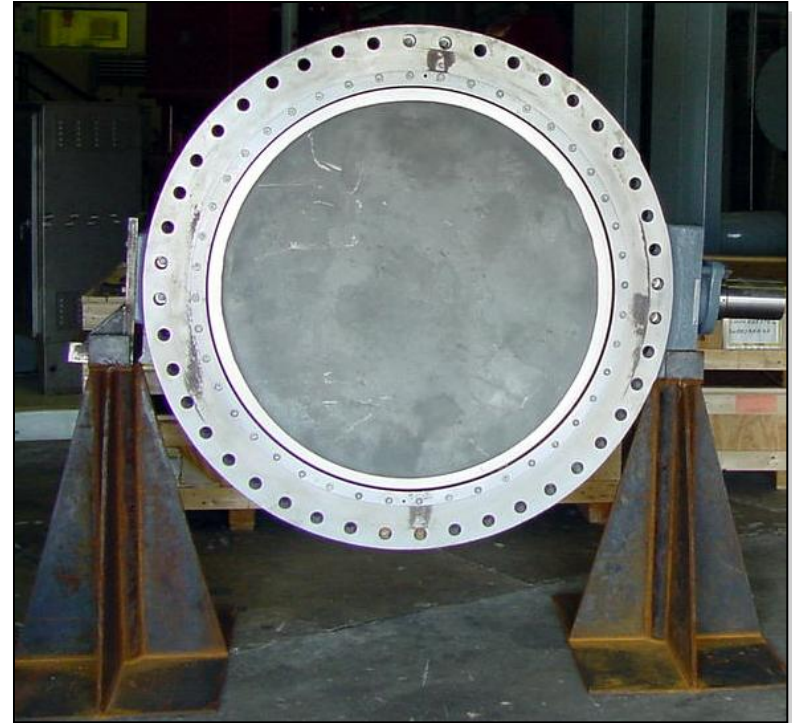
(H-1)

- **Description**
 - OMI's require the Sound Suppression 48" valves to open within two seconds, however the requirement is not specified in a higher level document
 - This is an important test on a critical component
 - Two of the three pre-launch Sound Suppression valves must open to satisfy launch commit criteria
 - Opening times are recorded but not trended
- **Recommendations**
 - Suggest trending 48" valve opening times using existing Maximo capabilities as a way of determining degradation
 - Add a review of the trends generated to the pre-S0007 review
 - Build routine Maximo work orders to collect and trend both the pre-launch static test and LCC data recorded during launch countdowns

- Evaluate alternatives for documenting design requirement for valve timing

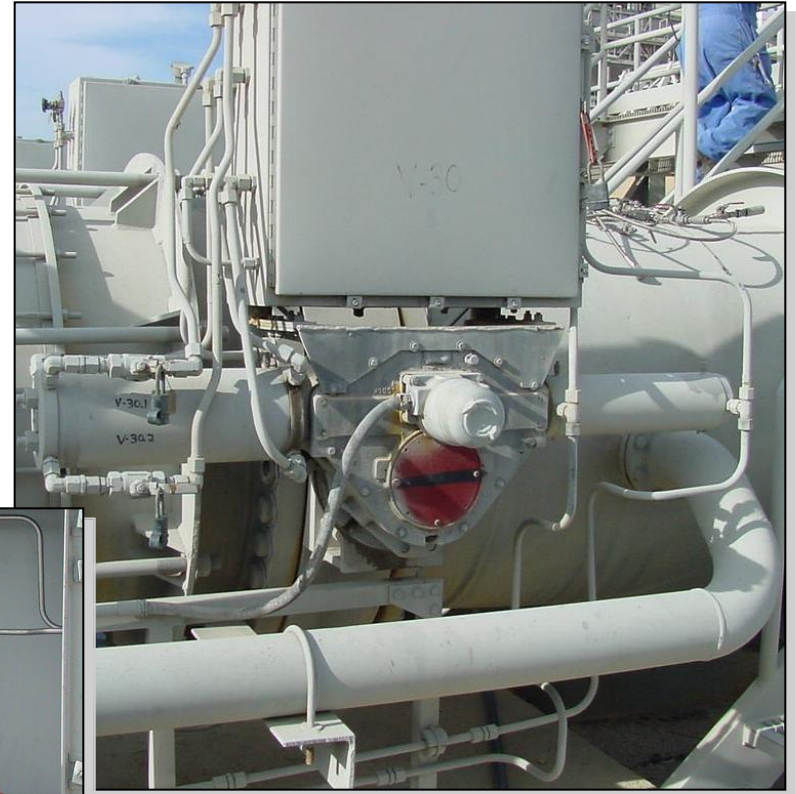
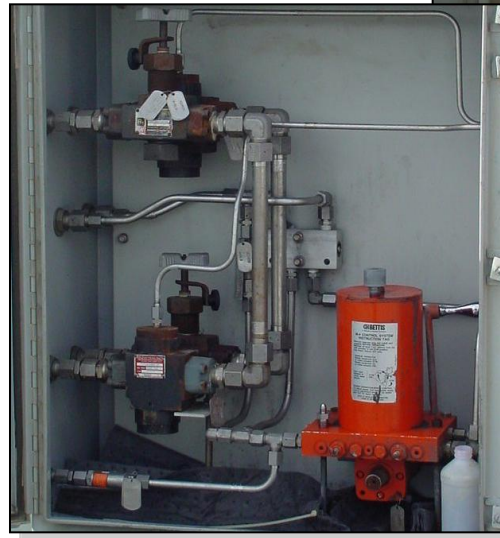
(H-2)

- **Description**
 - The hydraulic side of the actuators for the Sound Suppression 48" valves are overly complicated.
- **Recommendations**
 - Consider the cost / benefits of a re-designed actuator

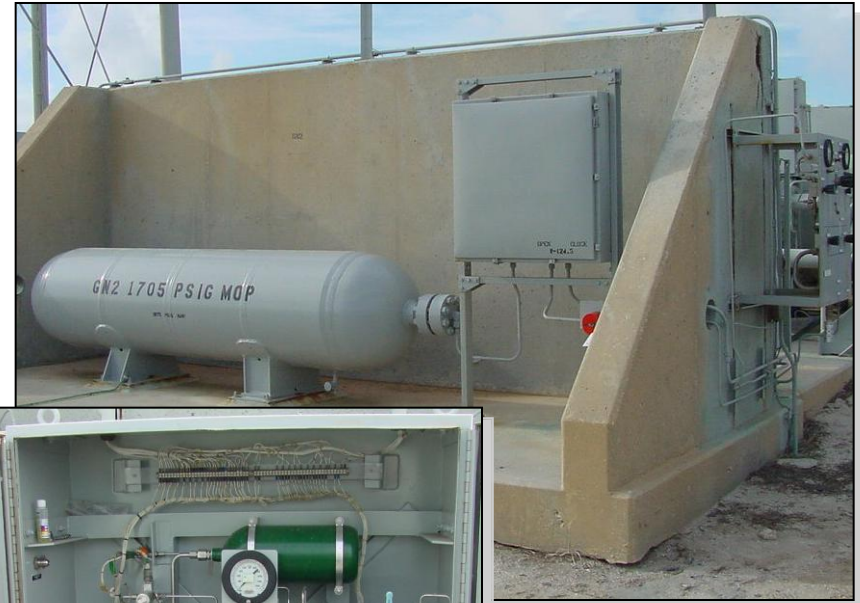
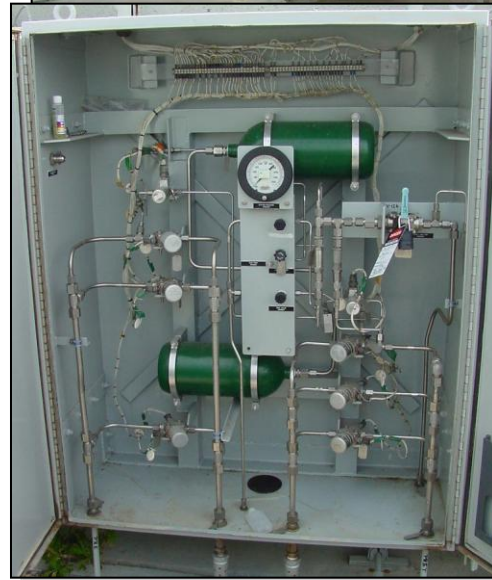
(H-3)

- At both Pads tubing in user panels and tubing in systems downstream of these panels will not be replaced by the GSS GN2 tubing replacement project
- GN2 tubing experiences known pitting problems.

- Need to address
- Selection of replacement tubing with a higher corrosion resistance is under development as part of the Pad tubing replacement project
 - Systems should use this new tubing

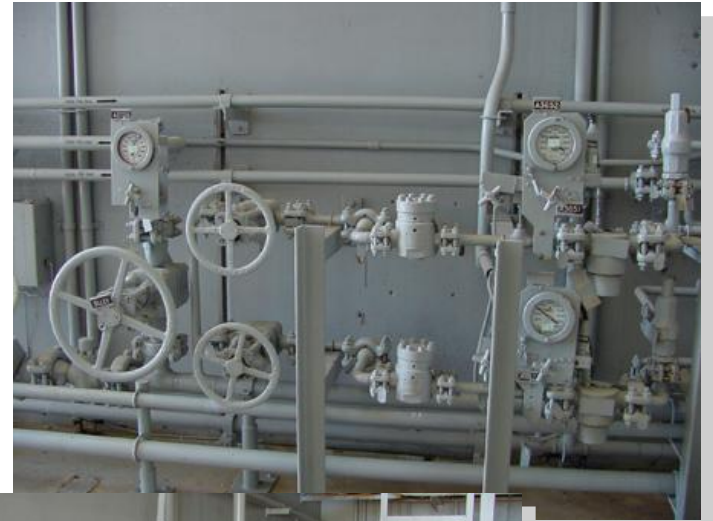
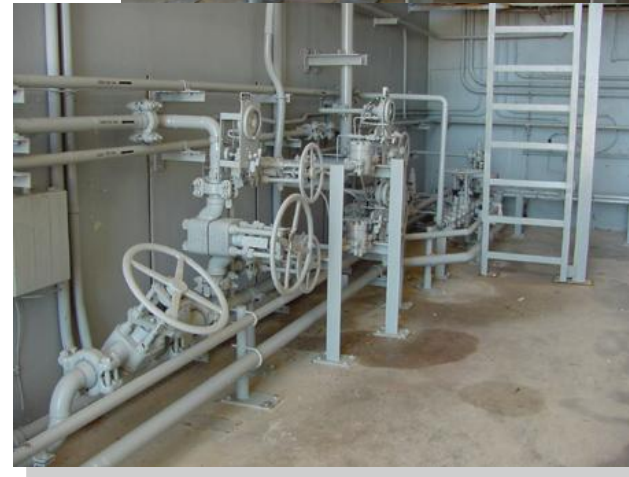
(H-4)

- **Description**
 - The only documented maintenance on the GN2 6K to 3K regulator panels are:
 - Performance of PVS (Pressure Vessel Certification) at 5 years
 - An annual filter change
 - The calibration of gauges and relief valves
- **Recommendations**
 - Develop preventive maintenance tasks to inspect for corrosion and other types of degradation

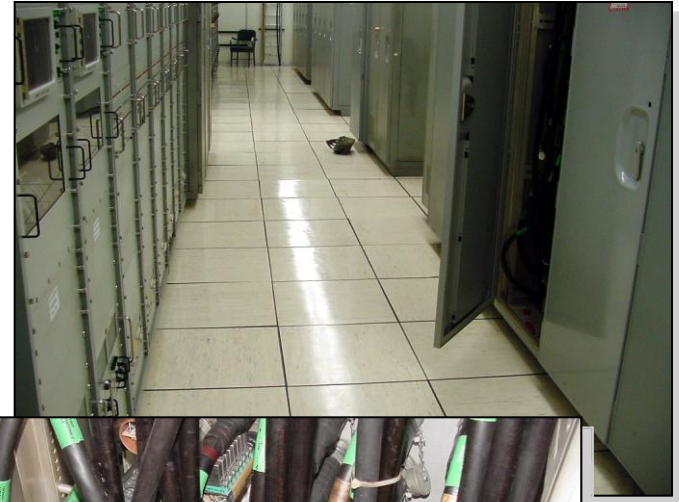
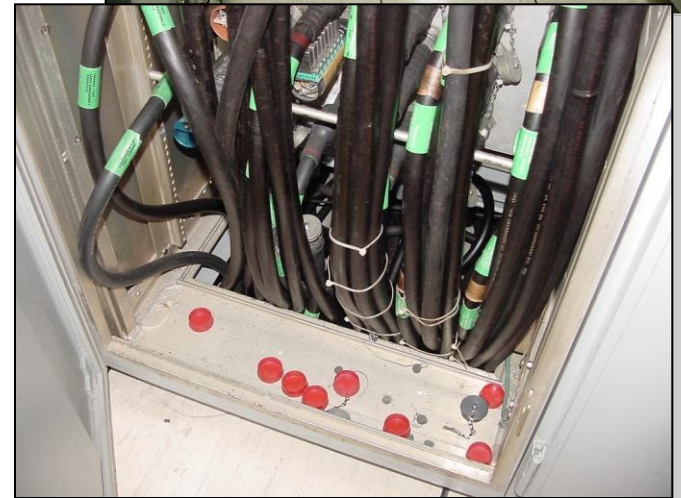
(H-5)

- Description
 - Not all Engineering departments may be aware of their hardware and component responsibilities
 - Responsibility for maintenance on the Receptacle Distribution rack in Pad room 210. Maintenance of cables that connect 28v DC power supplies to patch racks, and of the 28v DC power supplies themselves
- Recommendations
 - Clarify specific responsibility

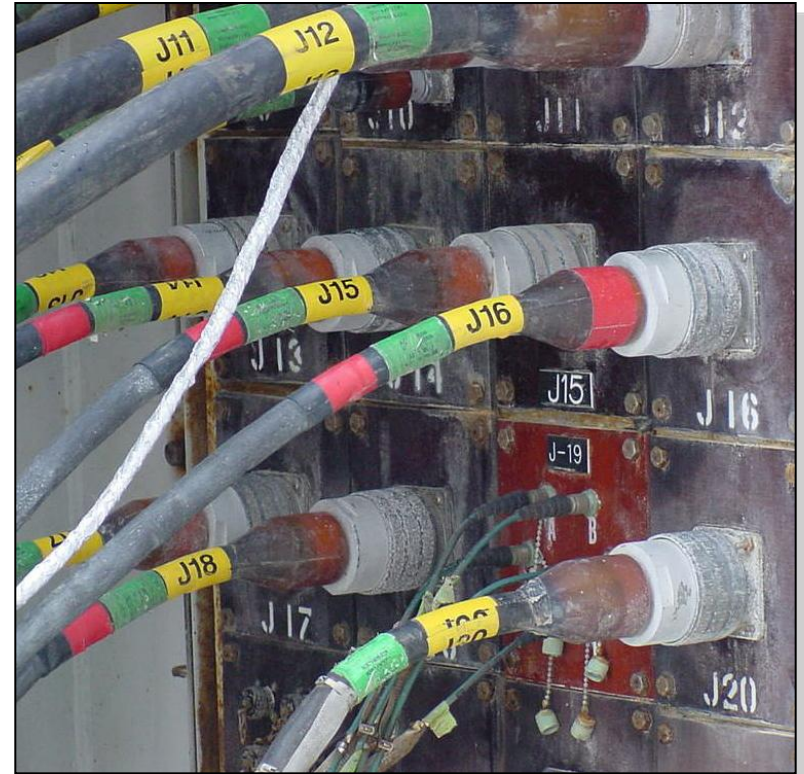
(H-6)

- **Description**
 - Sound Suppression cable connections on the MLP 9099 interface are interchangeable and can be mistakenly cross-connected
 - An instance of cross-connection was found on a recent flow
 - A large number of the protective caps for these connections are also untethered
- **Recommendations**
 - The 9099 Interface ERB Action Team is addressing this issue

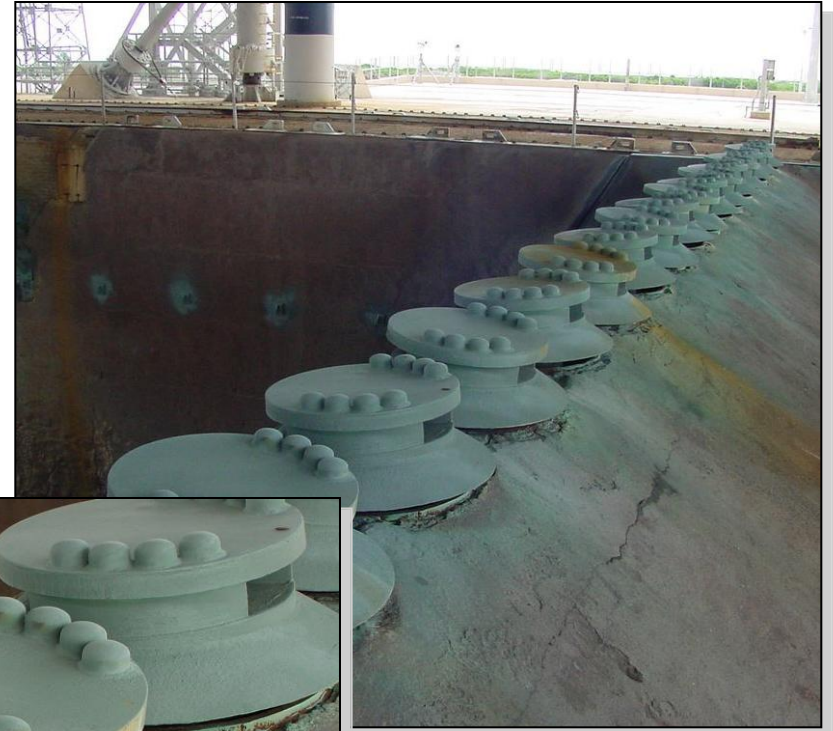
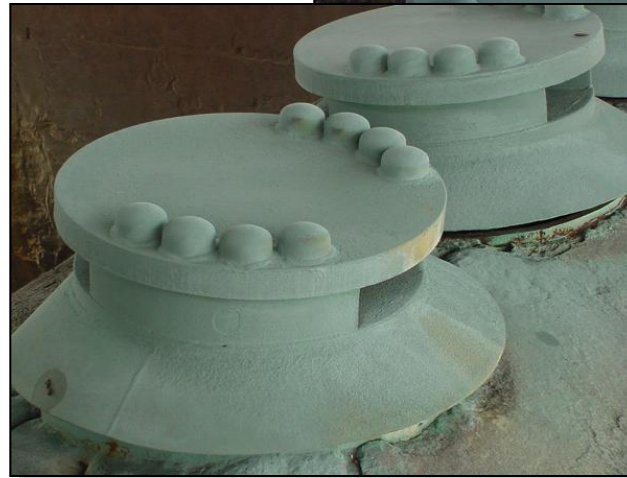
(H-7)

- **Description**
 - There is a concern as to whether welded caps over the nuts holding down flame trench mushroom water nozzles may be hiding extensive corrosion
- **Recommendations**
 - Perform a random sampling inspection of the nuts holding down flame trench mushroom nozzles
 - Would require temporary removal of some welded caps

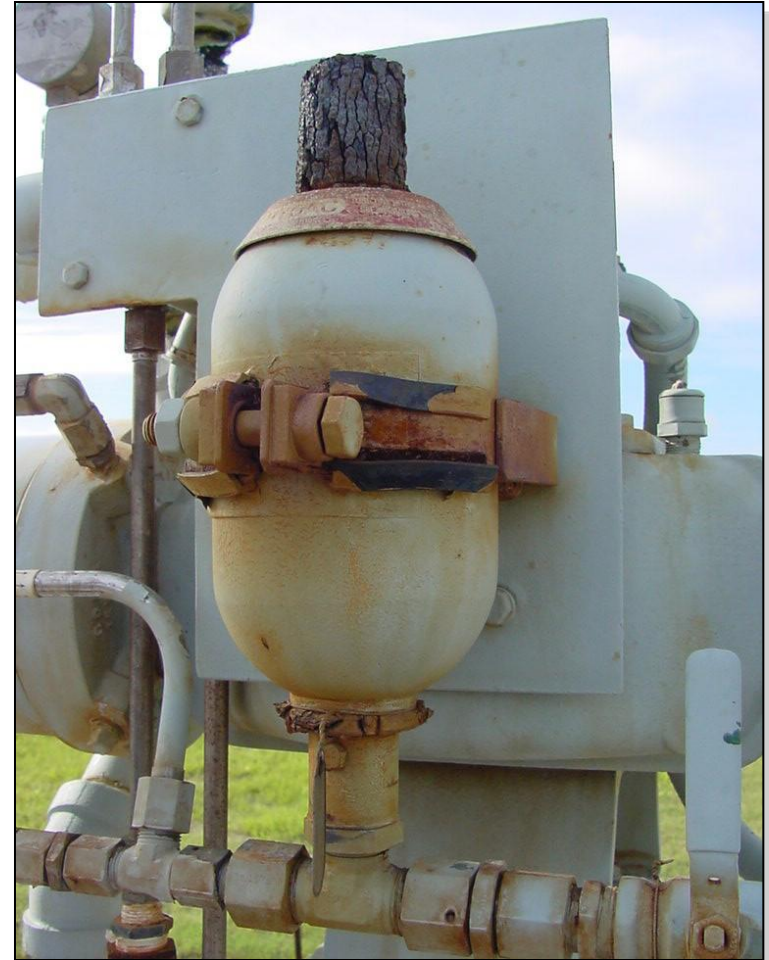
(P-1)

- Pad utilization does not allow adequate time to perform needed corrosion control with existing personnel
 - Sound Suppression valve V24 accumulator at Pad A is heavily corroded
 - General evidence of painting being performed over the top of corrosion

- Initiate evaluation / decision mechanism to address Pad corrosion coverage issues
- Possibly charter a special PIT Team to document pros and cons of the following three recommendations:
 1. Assign a painter to work with every shop;
 2. Assign a dedicated paint crew to each Launch Pad;
 3. Train techs to properly use Corrosion Control materials (locally stocked) and procedures within specified limits

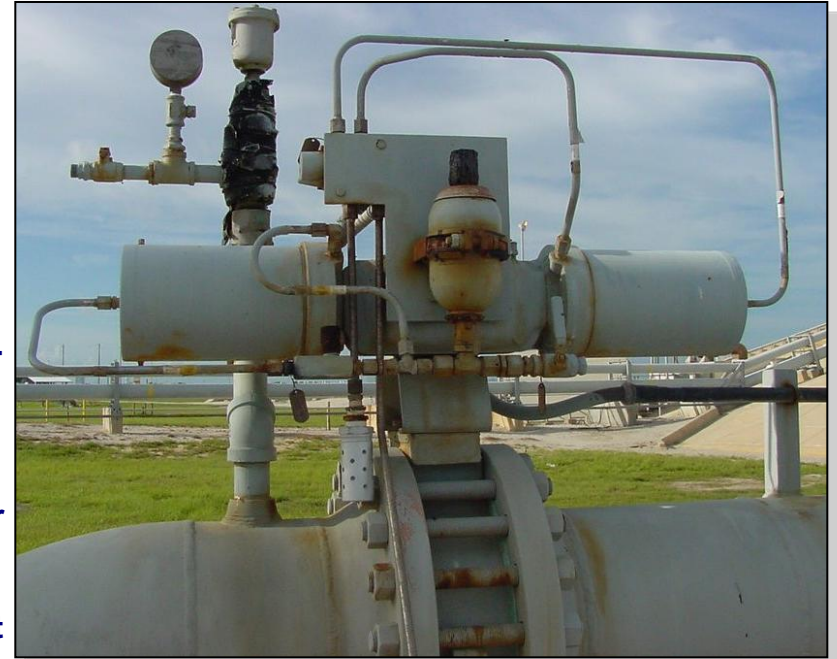
(P-2)

- **Description**
 - Proper corrosion treatment of launch pad components is much more difficult once they are installed
 - This is especially true if vendors were not held to following KSC corrosion coating specifications - (The Pad A V24 accumulator is a good case in point.)

- **Recommendations**
 - Ensure design coating specifications work in concert with the Corrosion SMRP (K-L70A-SMRP-002) to identify appropriate corrosion coatings for launch pad modifications and replacement parts

- Coordinate with Reliability Engineering to possibly add these areas of interest to their Design Review Checklist
 - Route components, expected to be used in the Launch Pad environment, for corrosion treatment of their exterior prior to being stored for spares

- Treatment to include:
 1. Complete removal of any Enamel paint used by OEM not compatible with KSC corrosion coatings
 2. Replacement of Carbon Steel Bolts with Galvanized Bolts. [Caution: Corrosion processing needs to ensure adequate protection of easily damaged valve seats and seals]

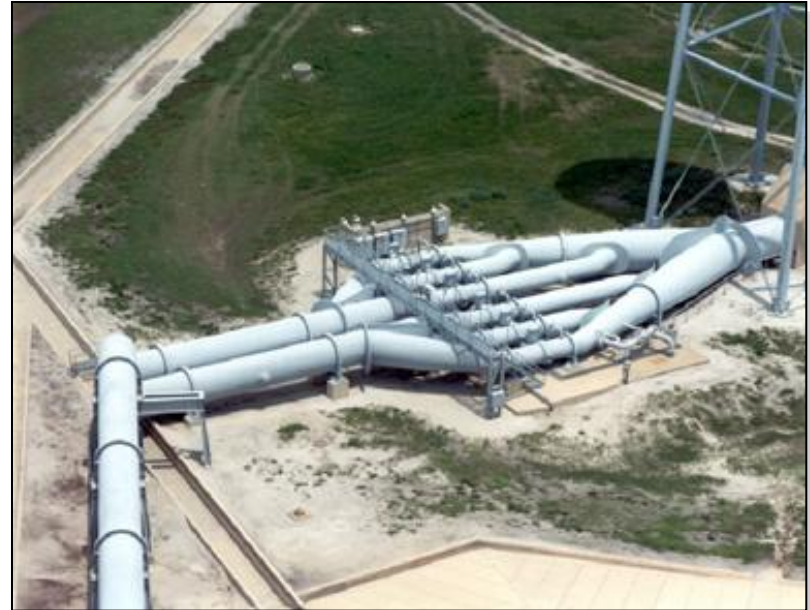
(P-3)

- **Description**
 - Interviews with Corrosion Control personnel suggested that some areas of the Sound Suppression valve complex require a more thorough washdown
- **Recommendations**
 - Review the post-launch procedure (S2005) to ensure an adequate wash-down rinses SRB residue and local salt sprays from Sound Suppression lines and associated component valves, etc.

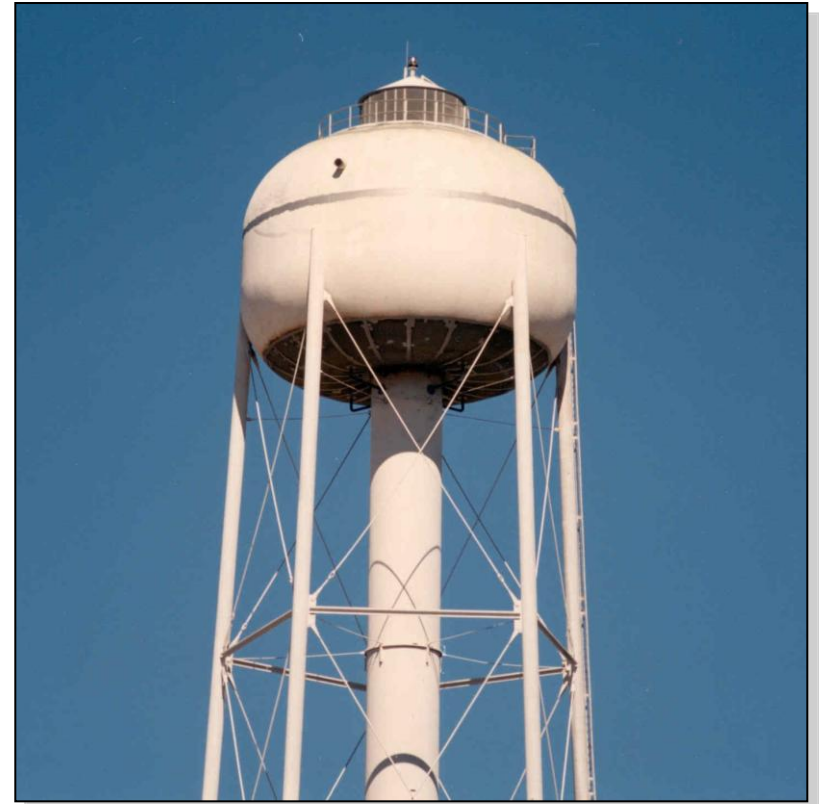
(P-4)

- **Description**
 - The current corrosion control effort does not adequately address concerns about the internal surfaces of the Sound Suppression System for smaller diameter piping
- **Recommendations**
 - The corrosion control process needs to be expanded to address issues pertaining to the interior of the smaller Sound Suppression piping
 - Options might include:
 1. Taking water samples to determine if the Sound Suppression water pipes become contaminated between flows
 2. Evaluating random sample pieces of the smaller pipes to see if any internal corrosion treatment would be necessary in those areas
 3. Use borescope inspection techniques

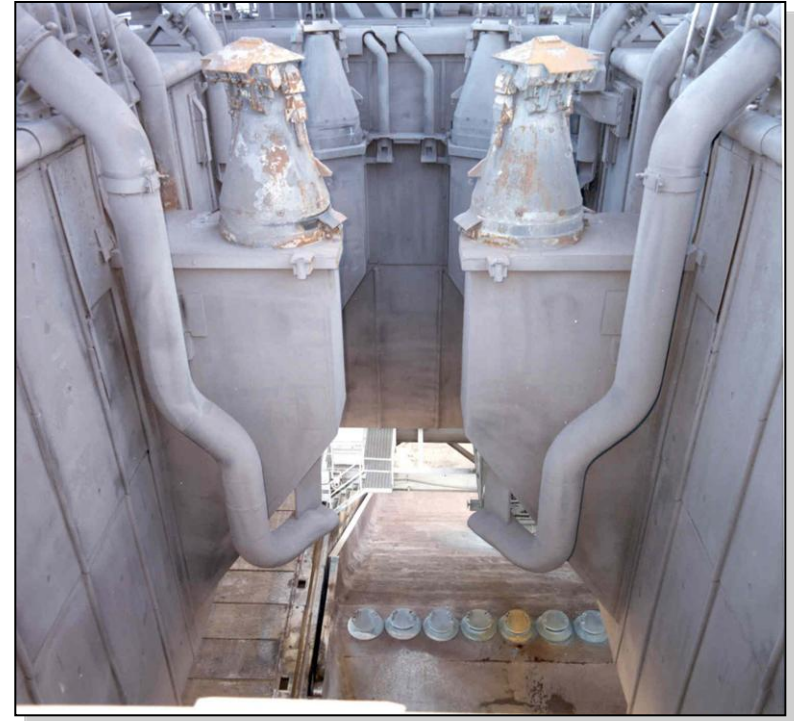
(P-5)

- Walk-down inspections are currently conducted on Sound Suppression systems on board the MLP post-launch
- These inspections have not been effective in finding the following problems:
 1. Water pipes inside the MLP had several clamps that appeared to be chaffing and at least one retaining nut that could be turned by hand.
 2. Piping / tubing appeared to be inadequately supported (e.g. lower rainbird drain valve)

- Consider initiating a detailed calendar-based MLP Sound Suppression pipe inspection to generate quantitative data on system integrity
- Make J-pipe, J-pipe support, and Side Flame Deflector weld integrity inspections part of the scheduled maintenance program

Note: Once developed a similar inspection approach needs to be taken on launch pad Sound Suppression ground based elements as well

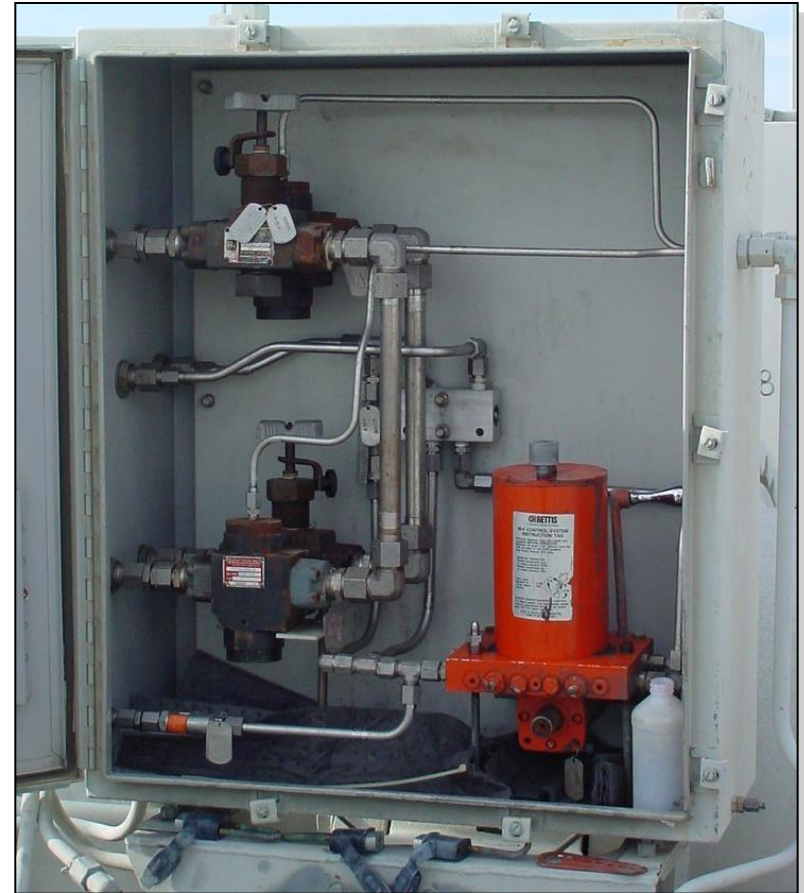
(P-6)

- **Description**
 - The 48” sound suppression valve bleed-down procedure to remove air from hydraulic system could be performed more effectively
- **Recommendations**
 - Change the existing 48” valve bleed-down procedure to improve maintenance practice

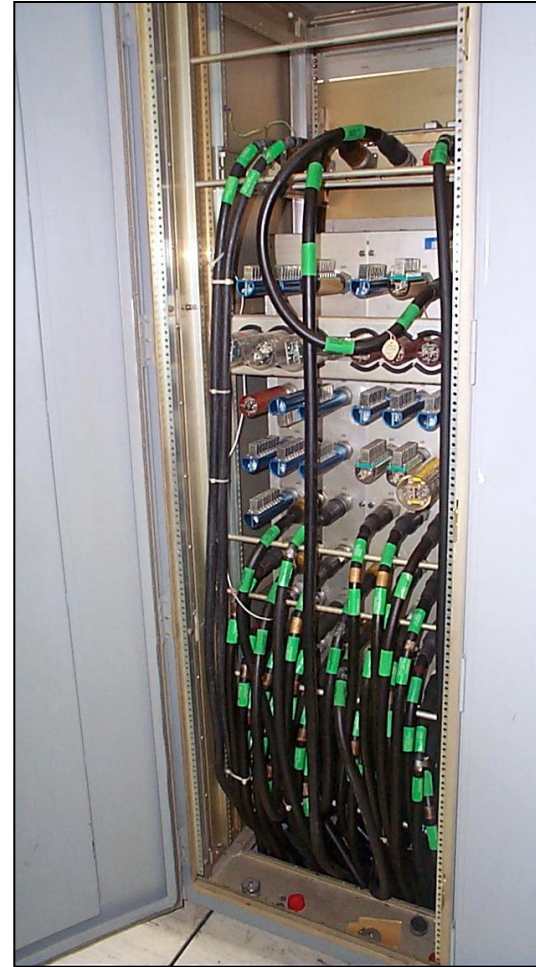
(P-7)

- **Description**
 - No complete inspection of Sound Suppression cable runs performed at any interval
- **Recommendations**
 - Suggest end-to-end (HIMS to end device) Sound Suppression cable inspections be performed, where accessible, at an interval to be determined

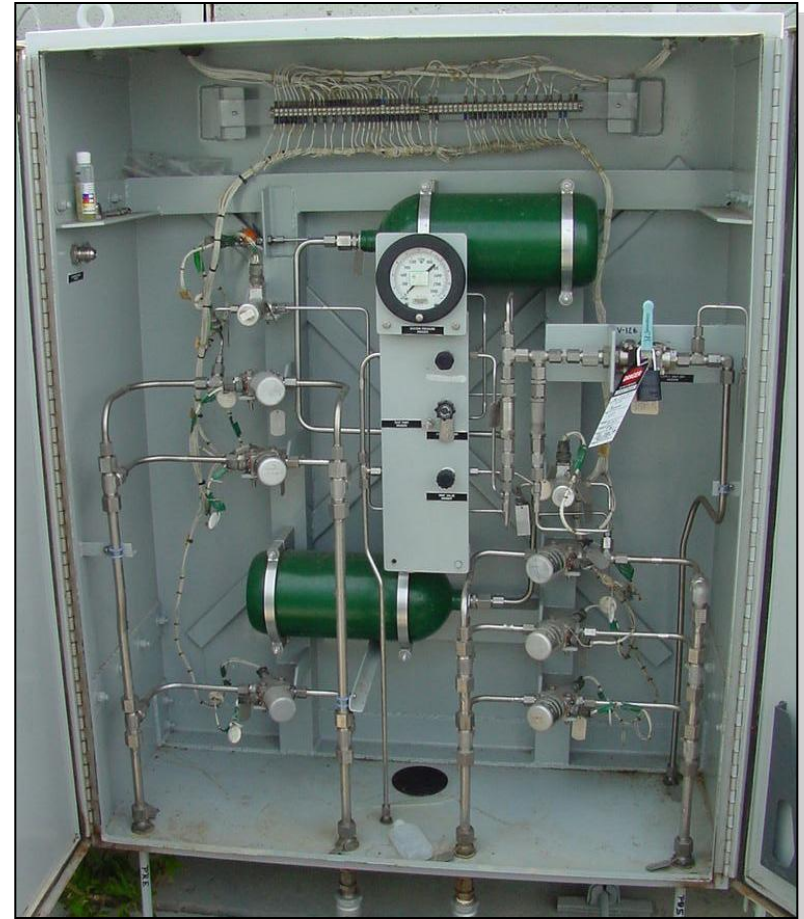
(P-8)

- **Description**
 - No explicit maintenance documented to establish that a positive purge exists on each Sound Suppression 48" valve control panel
 - Current process used by Technicians to inform Engineering of purge issues is not effective
- **Recommendations**
 - Consider entering condition assessment ratings on purged control cabinets into Maximo
 - This data could then be used to generate Engineering notices based on an established condition monitoring threshold

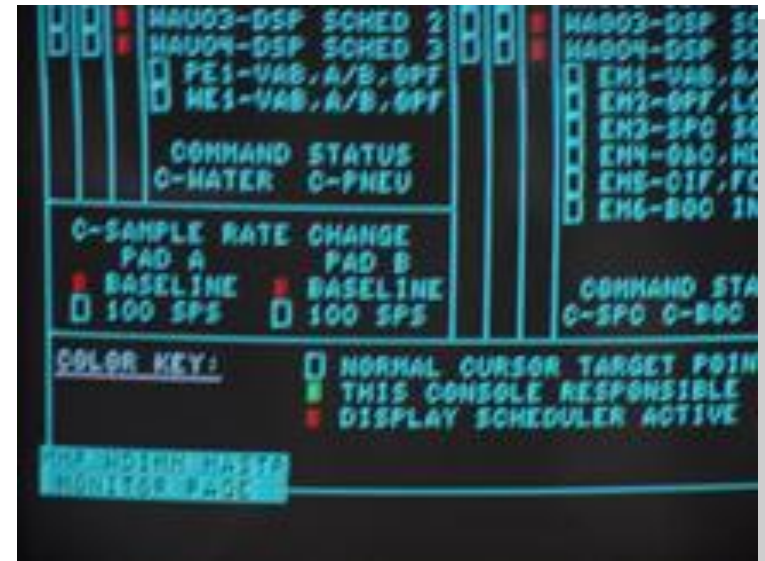
(P-11)

- Description
 - According to the current test procedures the Sound Suppression polling rate is not increased to high data rate during pre-launch tests
- Recommendations
 - Revise the documentation so when verifying limit switch position on the console, the polling rates are changed to match that experienced during an actual launch
